CASE STUDY: VEHICLE THREATS AT DAYCARE PLAYGROUNDS

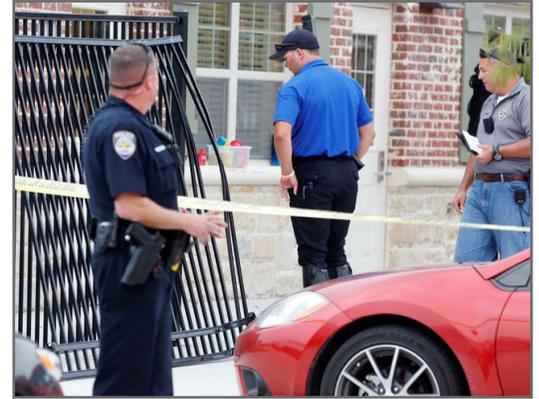
Frisco, TX daycare accident scene. Photo from Dallas News report.

Vehicle traffic during school hours pose a threat to the safety of children at play. There are an increasing number of reports reciting incidents of vehicles careening through parking lots and crashing through fences injuring children within daycare and childcare facilities. The fence systems in place are often too weak to mitigate the force of the vehicle regardless of how fast it is travelling at the time of impact. At a preschool in Texas, a teenage driver confused the brake and gas pedals and crashed through a fence, injuring children on the playground. Similar incidents took place in New Jersey, North Carolina and Kentucky.

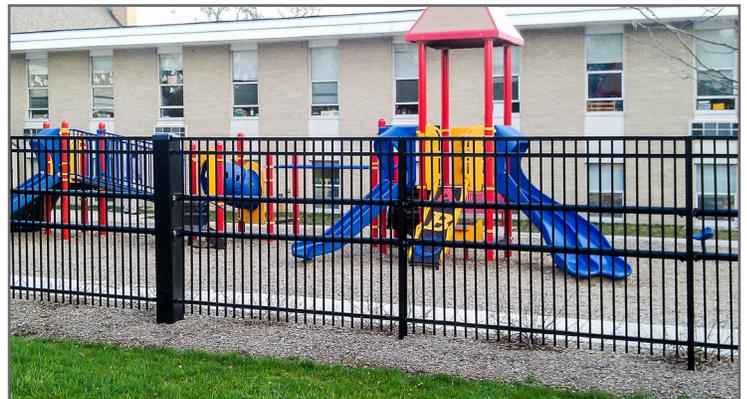
Stalwart II PU30-P2 fence shown outside school playground.

To prevent possible tragedies, Ameristar created the Stalwart II PU30-P2 fence system, which is specifically designed for Daycare and Preschool use. The system uses anti-ram steel cables that are integrated within the Montage Plus fence line. This passive cable barrier is engineered to provide impact protection from a 5500 lb. vehicle travelling 30 MPH. The PU30-P2 designation is derived from the ASTM F2656 standard, which indicates size, speed and test result of a barrier. Our fence system unites anti-ram cable and Montage Plus Majestic Pool, Pet & Play design to create a child-friendly fence barrier. This system highlights features such as a reduced 3" picket space and flush bottom rail designed for keeping children safe.
